POST-INCIDENT ANALYSIS

Brookhollow Apartment Fire

Presented to Sedgwick County – Board of County Commissioners and the City of Wichita – City Council

JOHN MAMMOSER & VERNON CHAMPLIN | DECEMBER 16, 2024

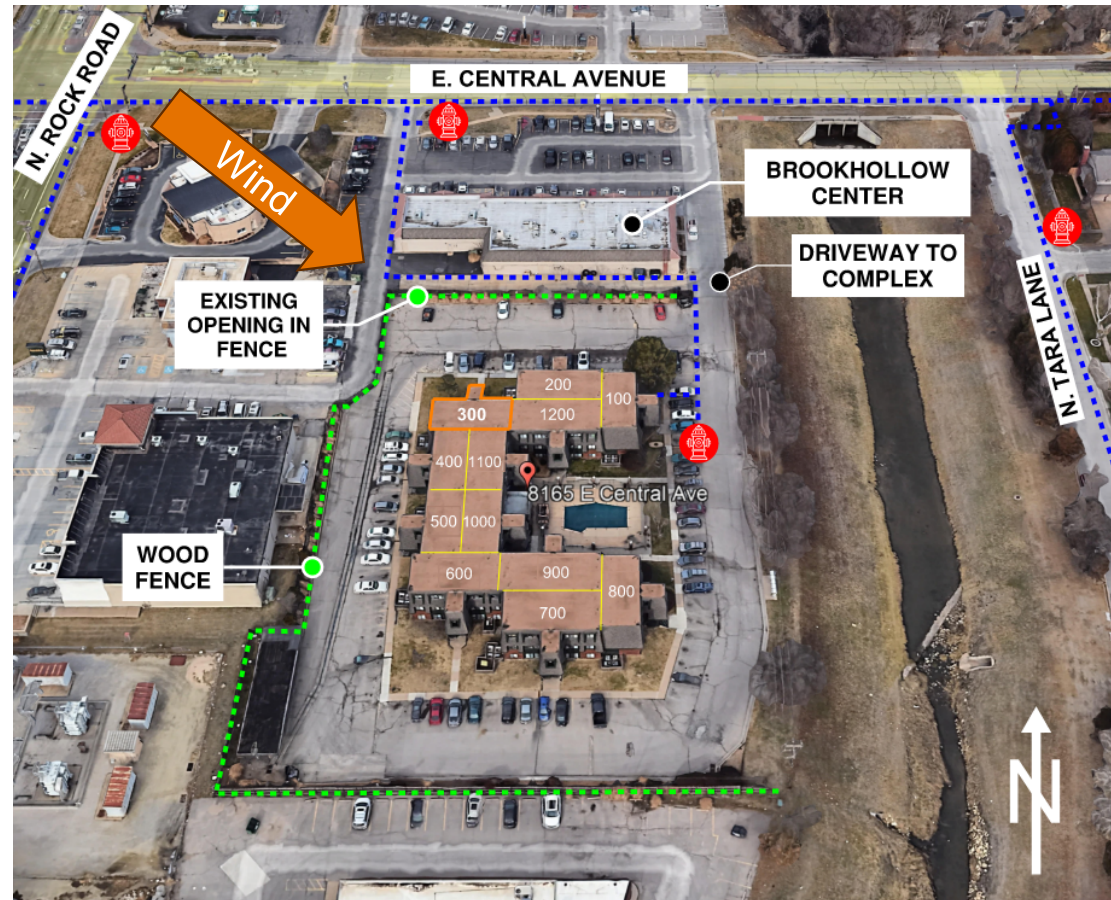
- + Brookhollow Apartment Complex – 8165 E. Central Ave.
 - Single vehicle entry/exit to complex
 - Comprised of 12 two-story “buildings” (garden-style apartments) with approximately 72 units total
 - Each building has a single exit to a common weather-protected but open stairwell

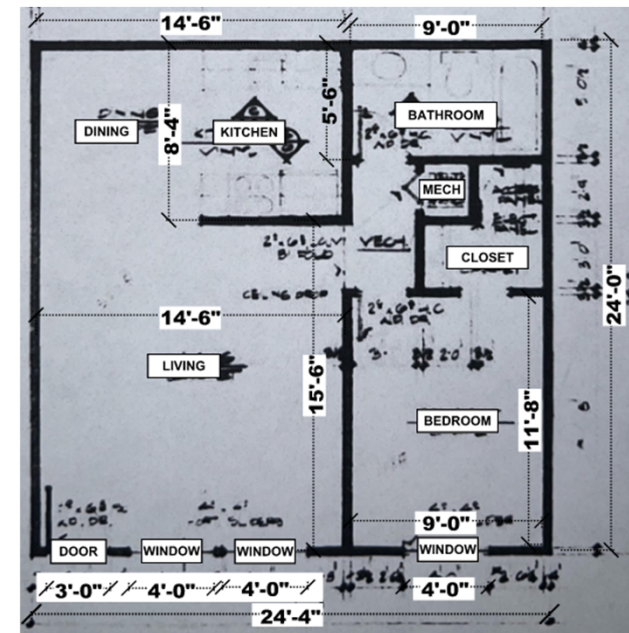
- + The fire is reported in front of Units 303, 304, 305, and 306 inside the exterior stair.
- + **4:10 a.m. – 4:13 a.m.** Portions of stairway roof collapsed on E15 and SQ 15.

Unit	Stairway	Unit
305		306
Unit		Unit
303		304
Unit		Unit
301		302

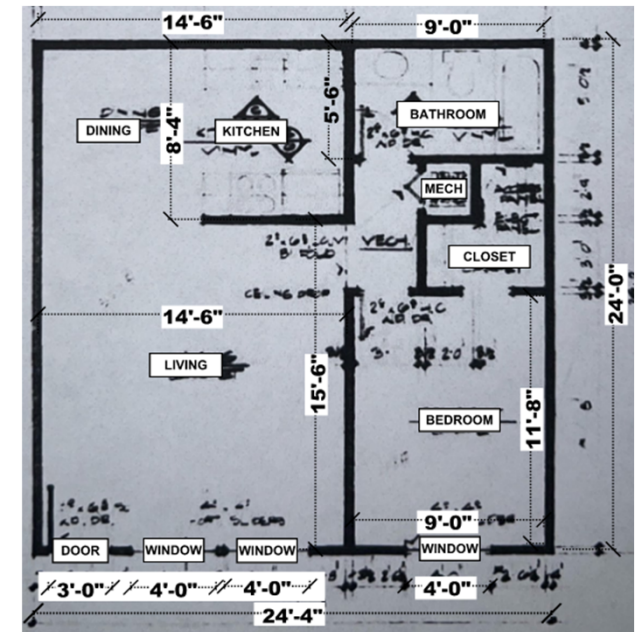
Unit	Stairway	Unit
305		306
Unit		Unit
303		304
Unit		Unit
301		302

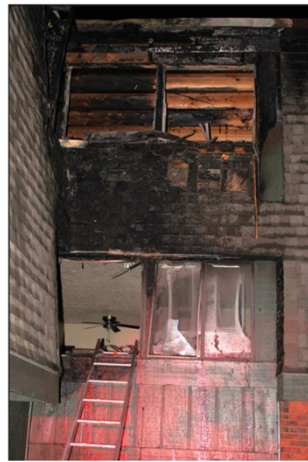
Figure 9: Post-fire damage to the exterior of Building 300. Left: Units 305 (top) 303 (middle) 301 (bottom) and east facing side of exit stairway enclosure. Right: North-facing side of exit stairway enclosure. (Credit: WFD FIU)

- + Engine 15 officer bailed out of the opening in the stair enclosure and Engine 15 nozzle was removed via a ground ladder from the front opening in the stairway enclosure.

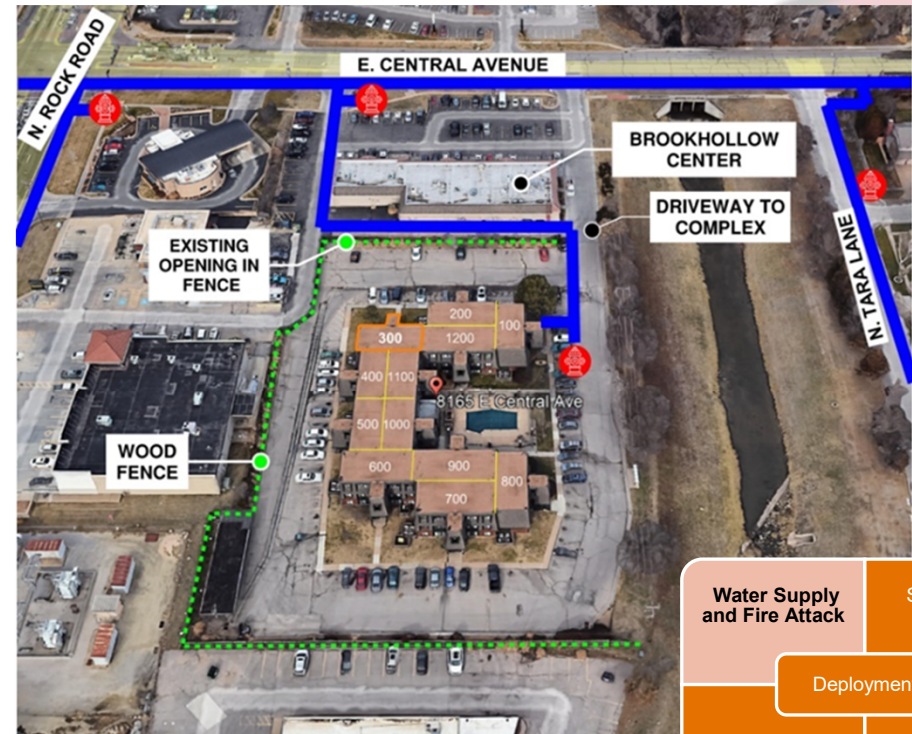
- + This wood frame, non-sprinklered, high-density, residential occupancy is served by a dead-end water main with one fire hydrant, on a dead-end road.
 - These conditions warrant extensive pre-incident planning. However, the WFD's provided pre-plan is weak.
- + The first arriving engine (E15) did not lay a supply line (forward or split lay) per OM, thus requiring others to hand-jack large-diameter hose... a time-consuming process.
- + The OM directs the second arriving engine to "not stage" and establish a water supply. E9 arrived and staged at a hydrant on Central, and E14 initiated a water supply plan.
- + E14's access was blocked by the privacy fence, so they attempted to take the hydrant within the Complex. However, TK5 was parked in front of it. TK5 was deploying outriggers when they were directed by E14 to reposition, causing additional water supply delays.

- + **Recommendation:** Consider limiting the number and size of handlines permitted to flow water from a booster tank before a water supply is established.
